Additional Plasmoid Marks on Electrolysis Cells

May 16, 1997 [Are These Plasmoid Marks?](#)

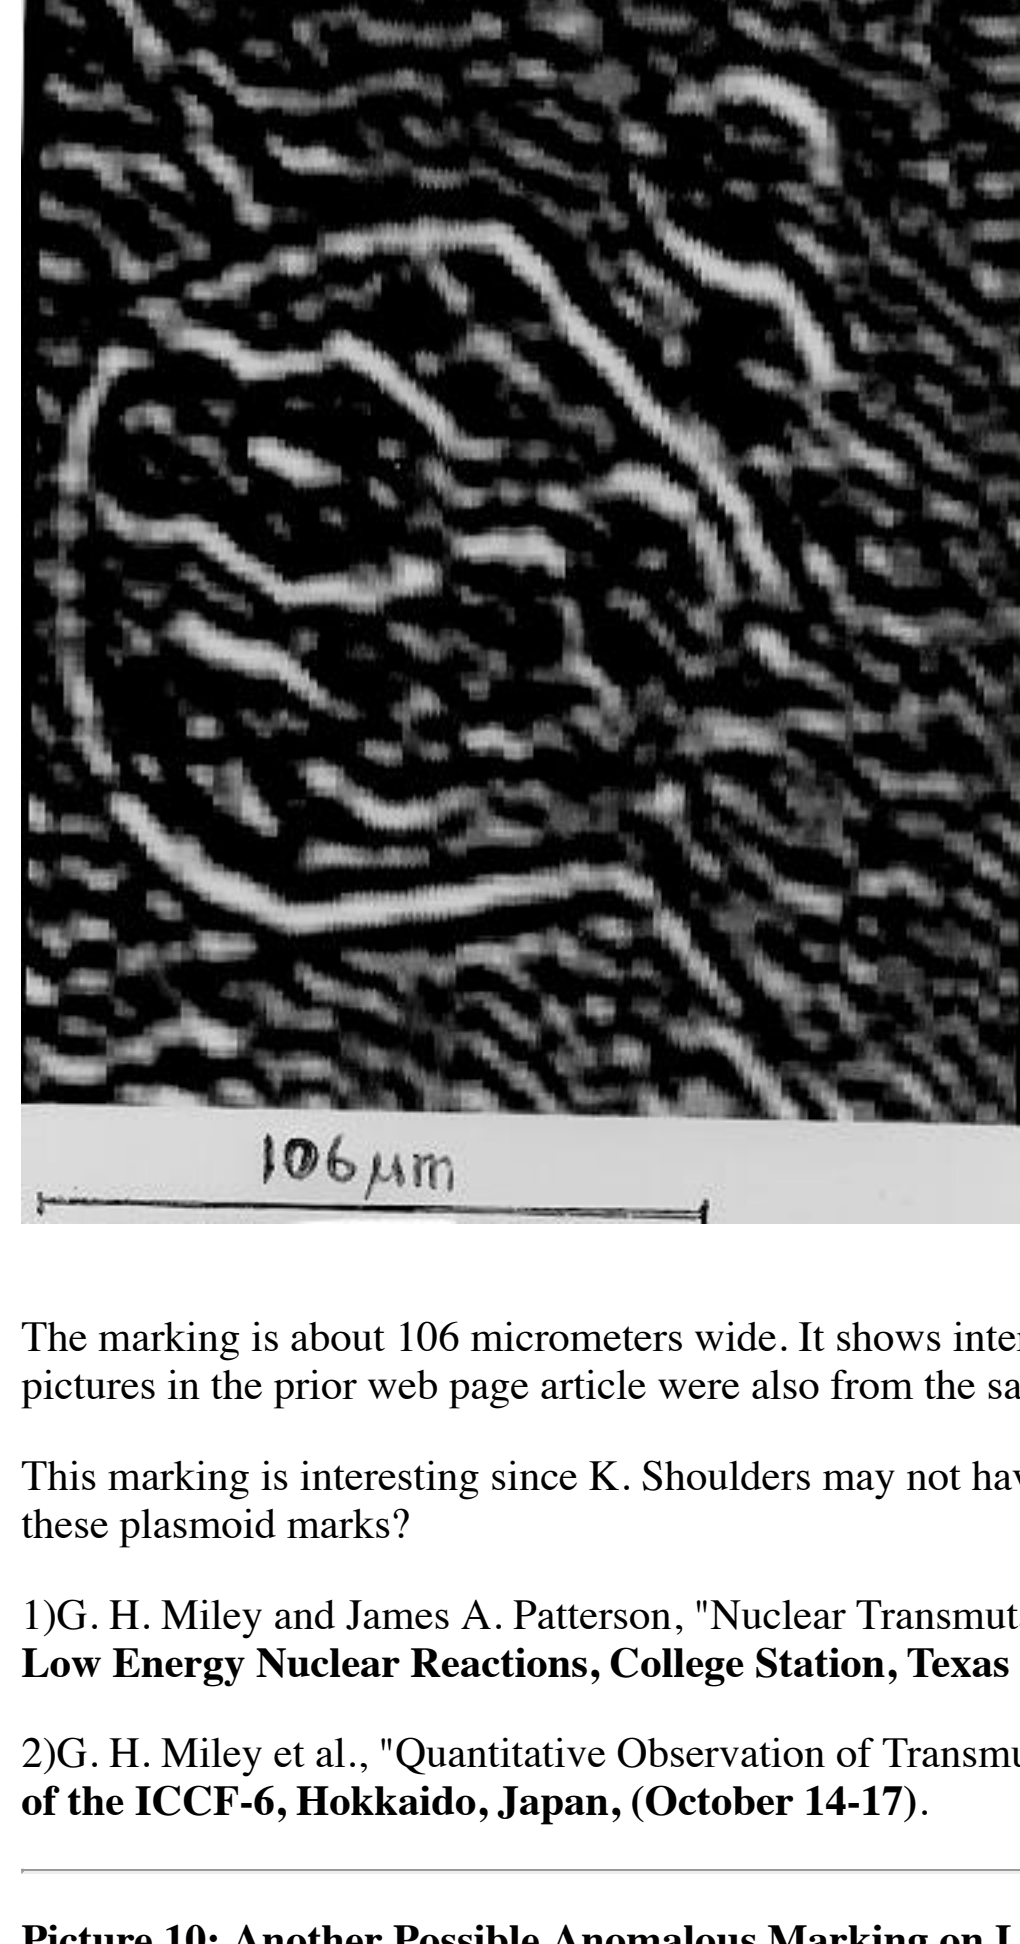
Picture 9: Ring Marks on Lexan of Nickel-Plastic Cell #8

Grayscale of anomalous marks on Lexan, Magnification x400

The marking is about 106 micrometers wide. It shows internal features of rings. This marking was on the Lexan casing of Nickel-Plastic Cell #8(1,2). Three pictures in the prior web page article were also from the same cell. Plastic beads were coated with nickel by sputtering.

This marking is interesting since K. Shoulders may not have produced any like these. T. Matsumoto has shown a few that are somewhat similar. But are these plasmoid marks?

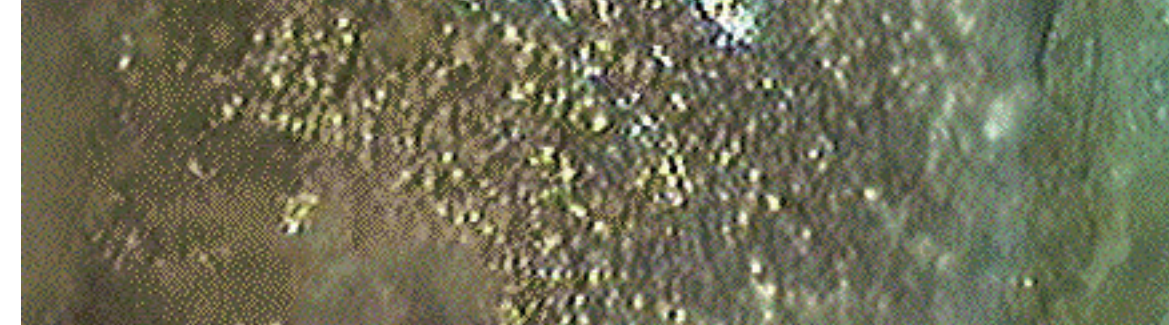
Picture 10: Another Possible Anomalous Marking on Lexan, for Comparison

Ni/Plastic Cell #8, Magnification x200

This is more than 100 micrometers wide. Grayscale picture.

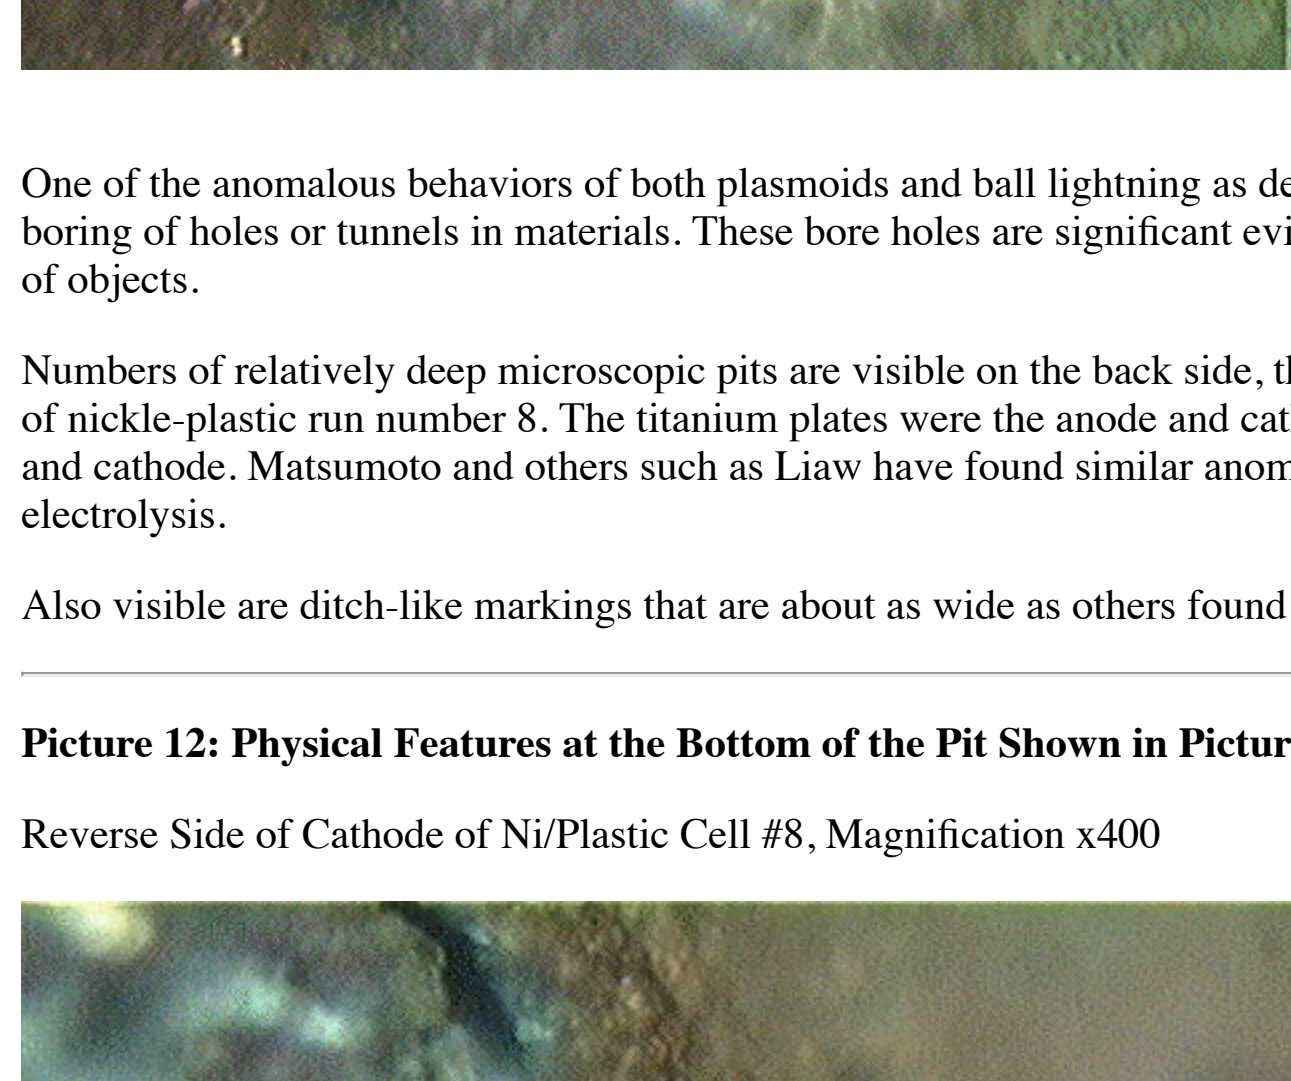
Picture 11: Pit on Reverse Side of Cathode, Magnification x400

One of the anomalous behaviors of both plasmoids and ball lightning as described by K. Shoulders, Matsumoto, and many ball lightning researchers is the boring of holes or tunnels in materials. These bore holes are significant evidence not only of plasmoids but of a fundamentally anomalous physical behavior of objects.

Numbers of relatively deep microscopic pits are visible on the back side, the side that faced away from the beads, of the titanium plates that held the beads of nickel-plastic run number 8. The titanium plates were the anode and cathode for the cell. There seem to be fewer such holes on the bead-side of the anode and cathode. Matsumoto and others such as Liaw have found similar anomalous markings that are about the same size that were produced during electrolysis.

Also visible are ditch-like markings that are about as wide as others found by Shoulders and Matsumoto.

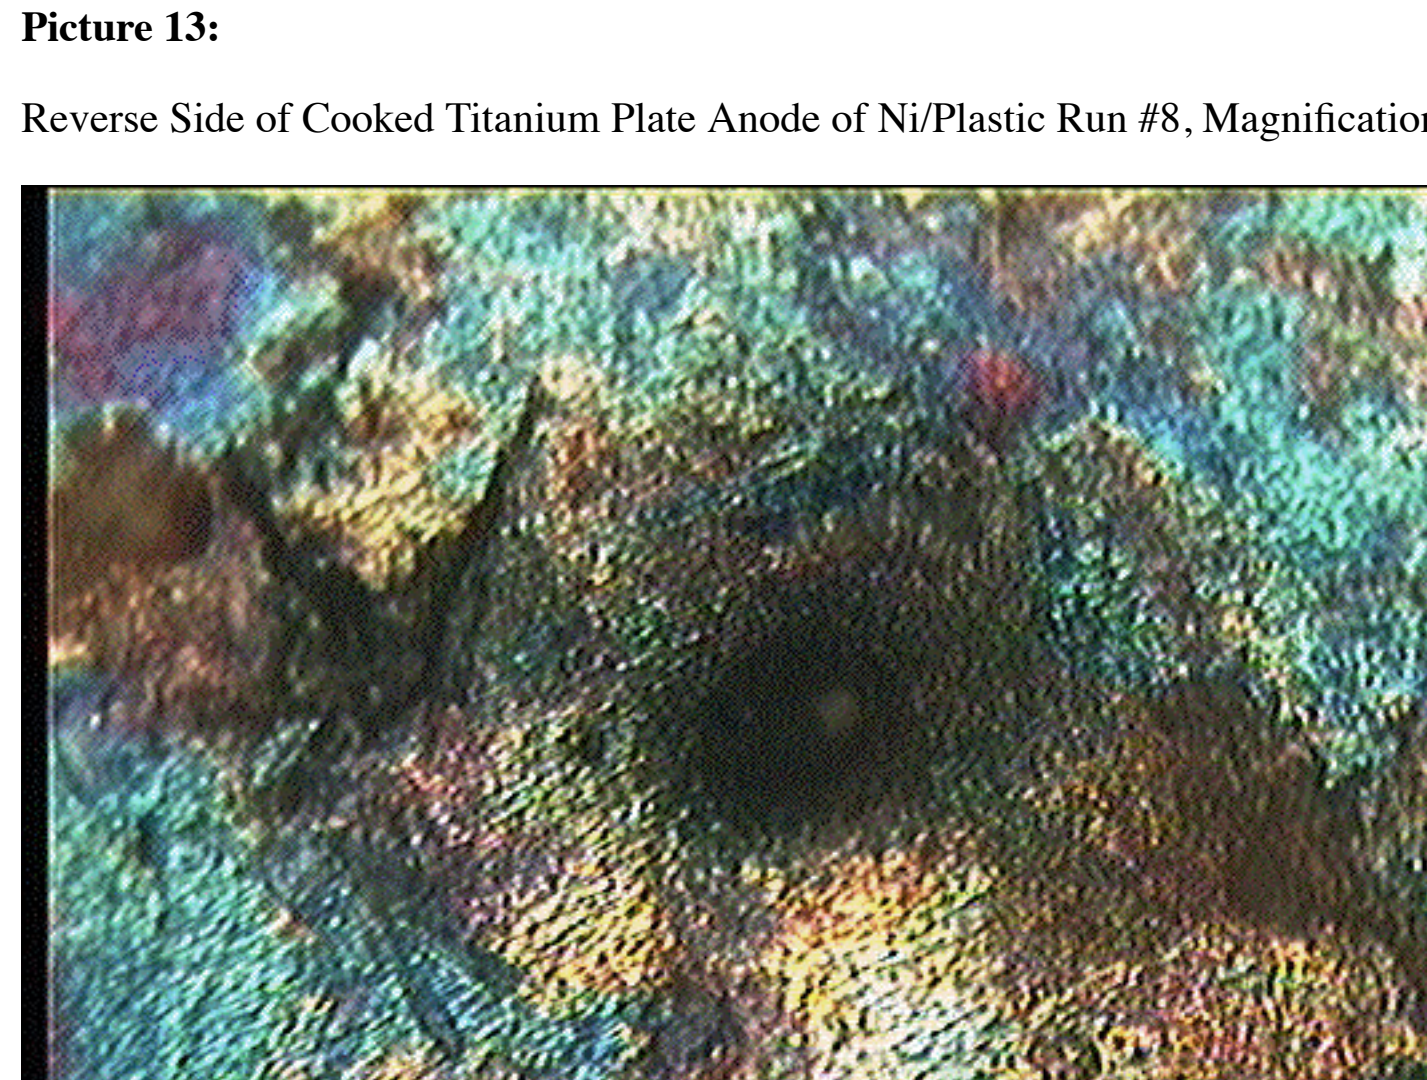
Picture 12: Physical Features at the Bottom of the Pit Shown in Picture 11

Reverse Side of Cathode of Ni/Plastic Cell #8, Magnification x400

The same pit as shown in Picture 11 is shown here with the microscope focused at the bottom of the pit. It would be interesting to determine how deep such pits are, as Silver and Dash et. al had done. Little pits, and perhaps very tiny ring or groove marks are visible.

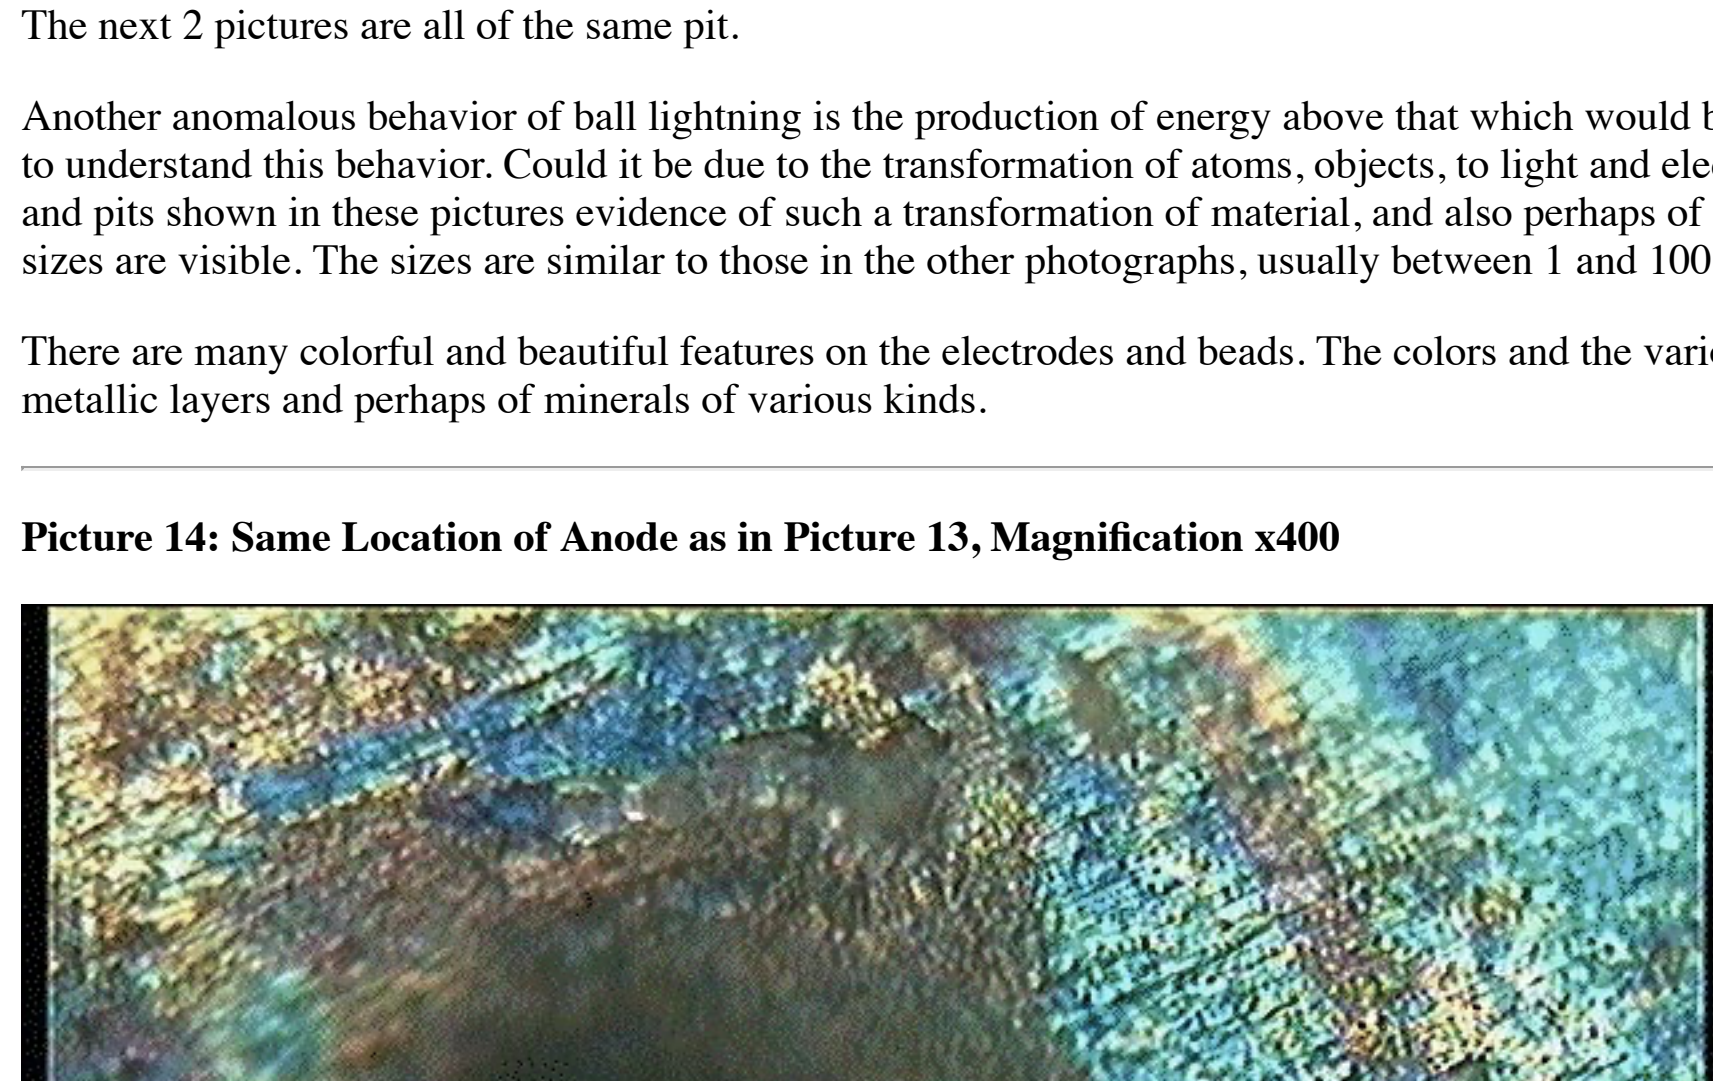
Picture 13:

Reverse Side of Cooked Titanium Plate Anode of Ni/Plastic Run #8, Magnification x200

The next 2 pictures are all of the same pit.

Another anomalous behavior of ball lightning is the production of energy above that which would be ascribed to chemical reactions. It would be interesting to understand this behavior. Could it be due to the transformation of atoms, objects, to light and electricity? This was my original proposal. Are the grooves and pits shown in these pictures evidence of such a transformation of material, and also perhaps of elemental transformation? Grooves and pits of various sizes are visible. The sizes are similar to those in the other photographs, usually between 1 and 100 micrometers.

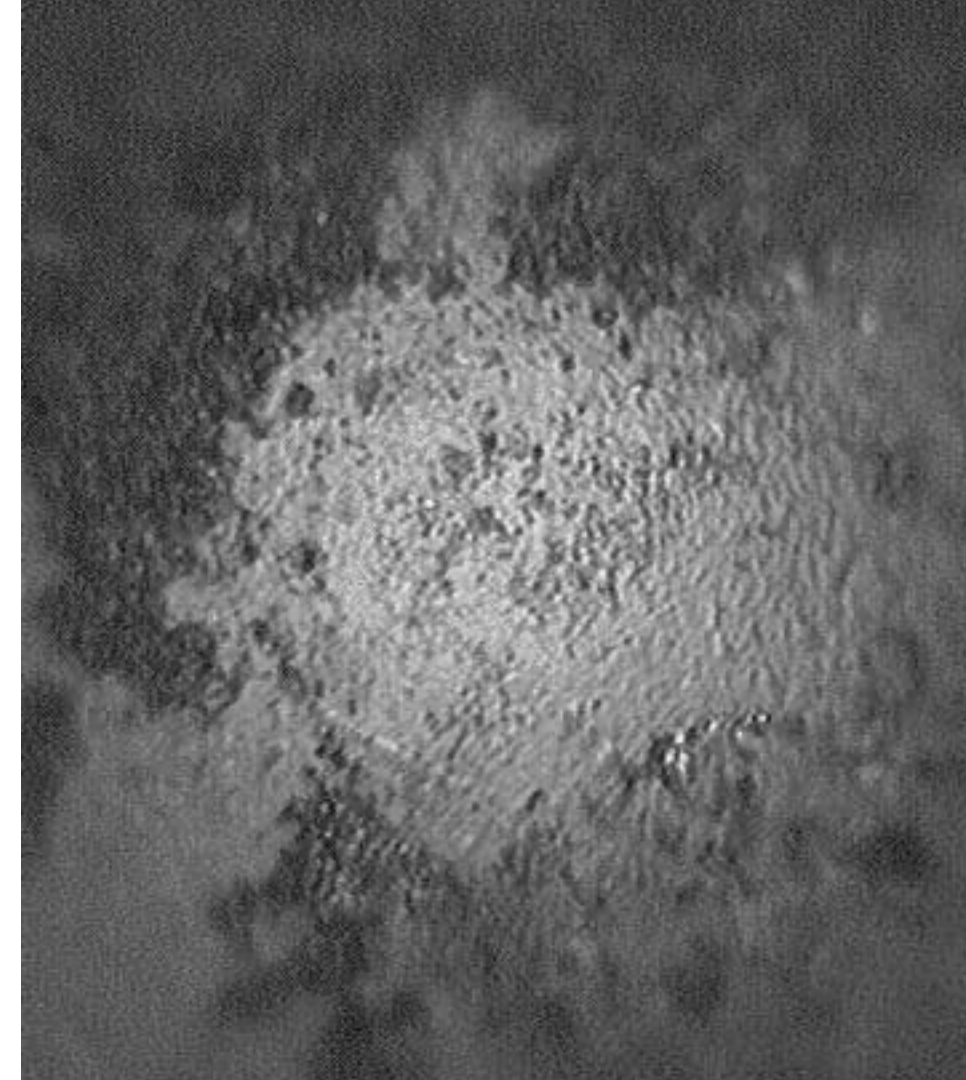
Photograph 20: Trail-like Marks, Bumps, and Grooves on Beads of Ni/Plastic Cell #8

Partially Flaked Off Bead of Ni/Plastic Cell #8

The dozens or hundreds of trail or groove like marks discernable here are commonly found on the various parts of various cells. Are these plasmoid marks? A ring mark is visible. Compare to the marks shown already by Bostick and Nardi, Shoulders, Matsumoto, and Silver and Dash et al. If these are plasmoid marks, then apparently there are many microscopic plasmoids produced in such electrolysis devices.
